| Hringtún 25, Dalvík | | | |
| Burðarvirki: Hliðarmynd sperra Snið í hús | | Kvarði 1:50 Kvarði 1:20 | |

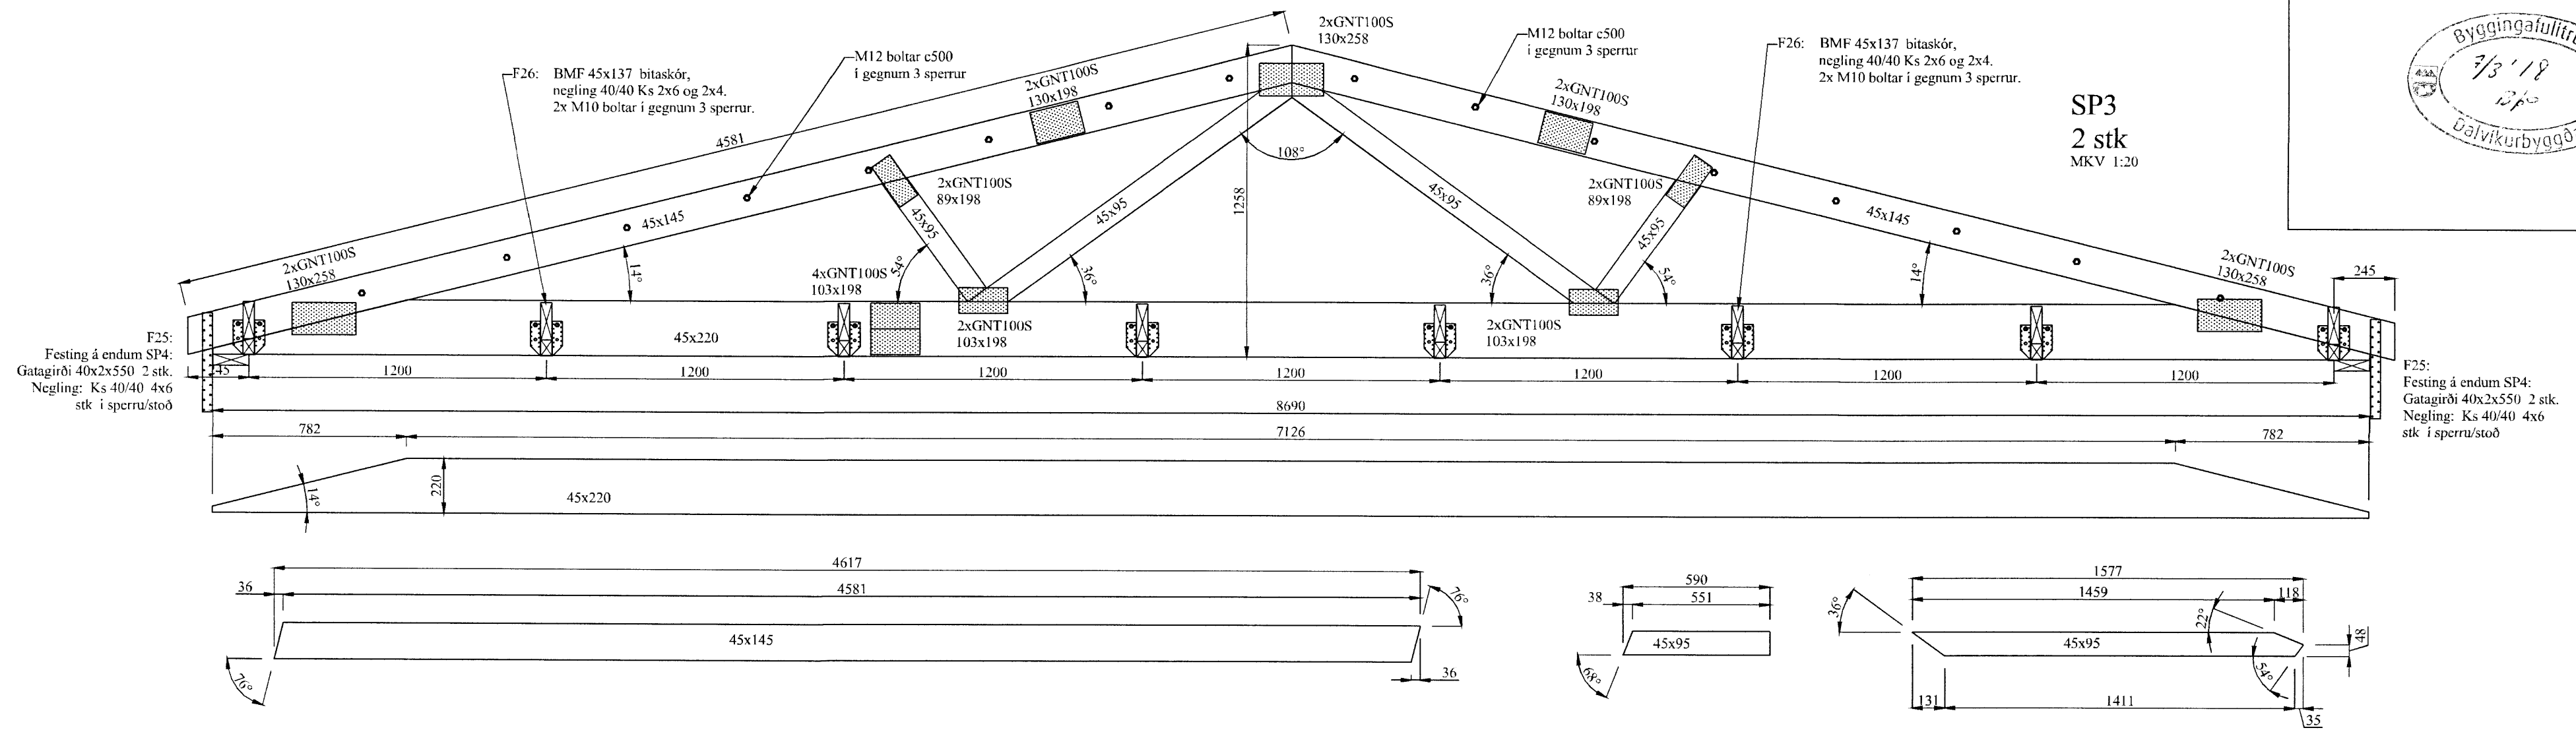
Hliðarmynd sperra
MKV. 1:20

SP3
2 stk
MKV 1:20
